NASA TM X-71671

**RESULTS OF TC-1 BOOST PUMP ICING TESTS IN
THE SPACE POWER FACILITY**

by L. C. Gentile and Robert J. Walter
Lewis Research Center
Cleveland, Ohio
February 1975

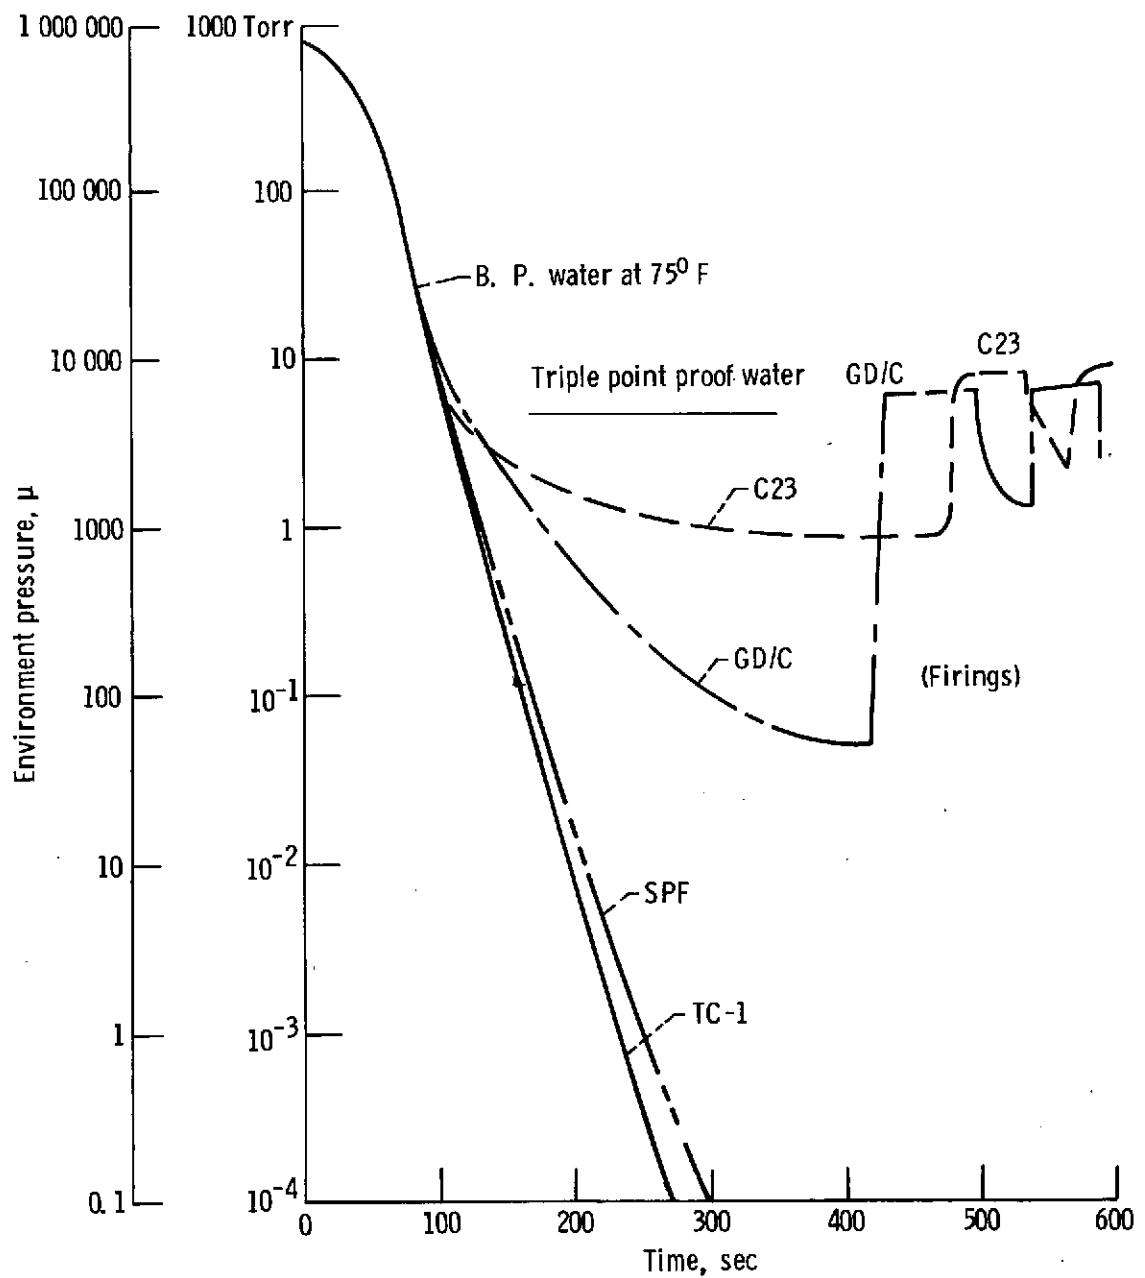
Figure 1.

Tests were conducted at General Dynamics and at Lewis Research Center in Cleveland to investigate this failure mode. The results were inconclusive, however, because neither facility could sustain the ascent pressure below 5 torr during testing (fig. 1). The triple point of water is 4 torr. Ice below the triple point sublimes directly to vapor which requires considerably more energy than the usual melting process. Therefore, the tests were repeated in the NASA Lewis Space Power Facility where the required low pressure could be attained.

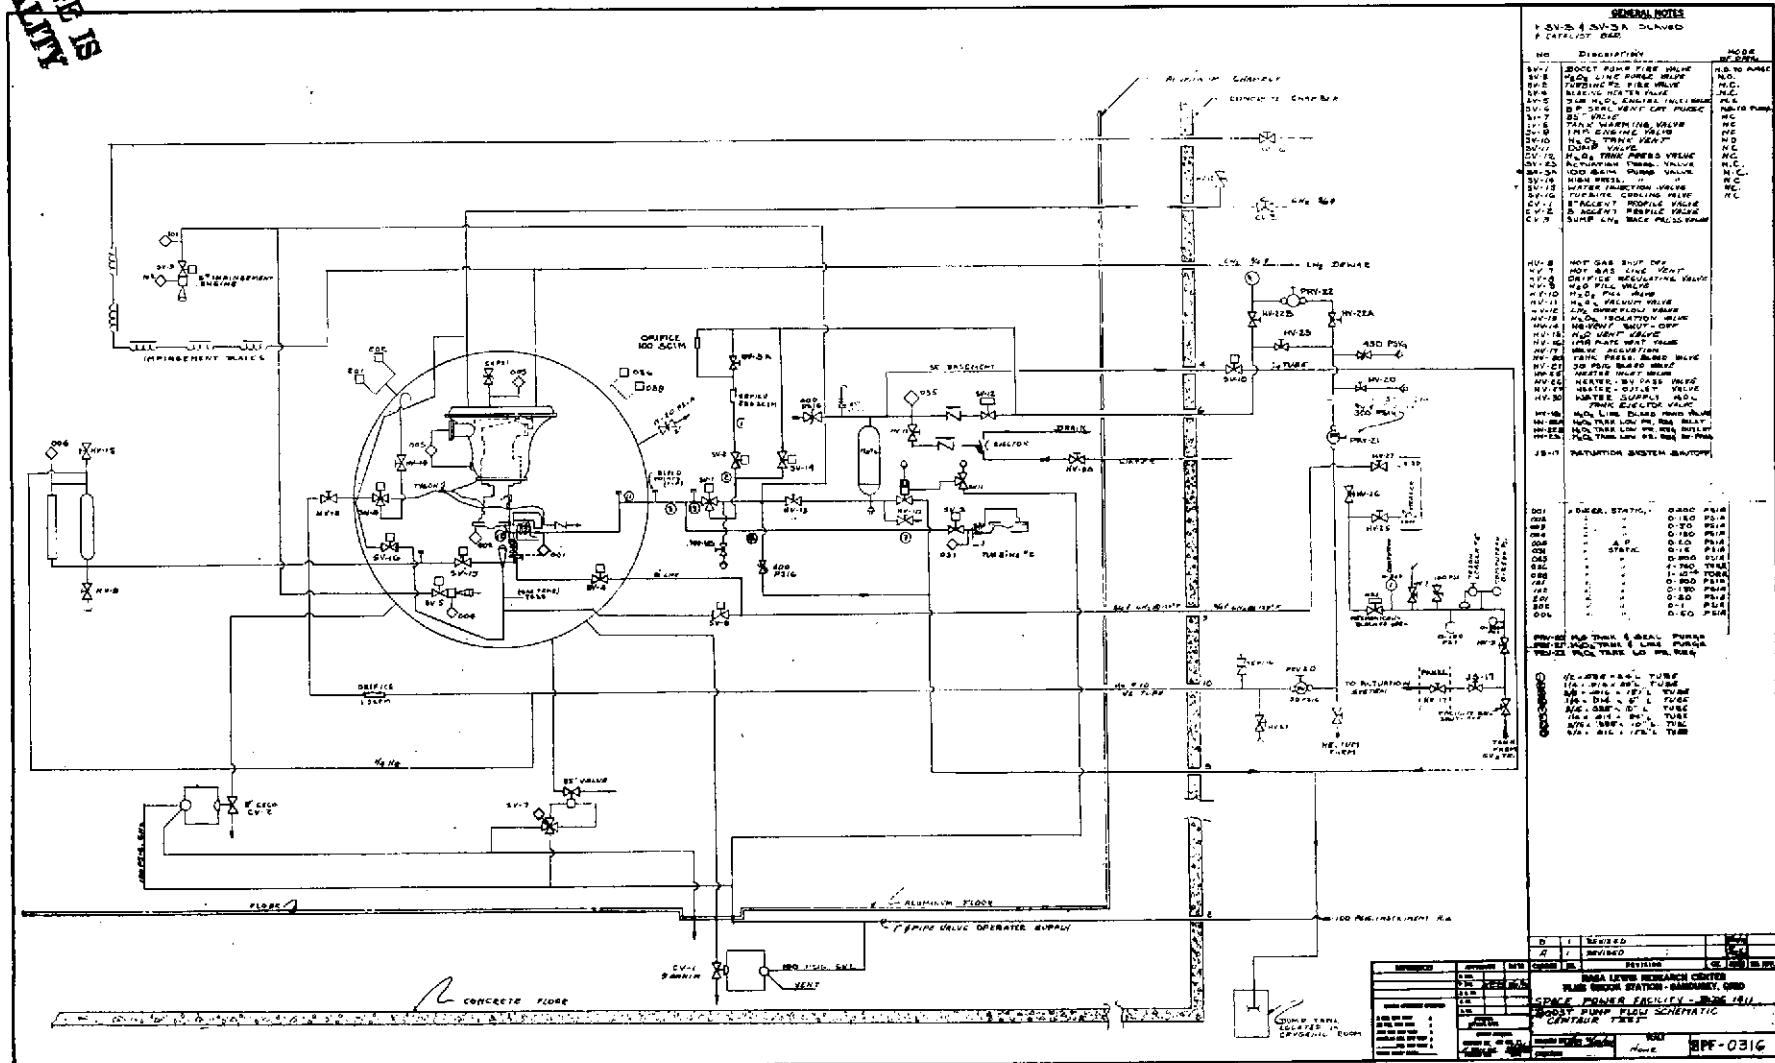
Figure 2.

The test hardware which was assembled for the boost pump failure mechanism tests is shown in figure 2. Interfaces with the facility are also shown. The test hardware consisted of a Centaur LOX sump, LOX boost pump/turbine system, and essential parts of the airborne hydrogen peroxide and gaseous helium purge systems. The sump, boost pump, turbine, and BPFV are previously used flight-type hardware, and are the same in all significant aspects as the hardware used on the TC-1 flight. The structure on which the sump is mounted in the tank was capable of small motions caused by the shaker. All fluid and instrumentation lines connecting to the sump, pump, or turbine were capable of enough motion to allow for thermal contraction and shaker motions. The hydrogen peroxide system tubing was assembled in a horizontal plane to simulate the near zero-g TC-1 flight condition which existed after (T + 469.5 sec) the time of Titan Stage II cutoff.

(1) A high-pressure purge valve was installed (SV-12, fig. 2) to purge the hydrogen peroxide between the boost pump feed valve (BPFV or SV-1, fig. 2) and the turbine. The flight purge valve flow rate of 100 SCIM was not sufficient to purge the hydrogen peroxide between tests. The high-pressure purge valve was utilized to purge out the hydrogen peroxide between tests. The high-pressure purge valve was installed prior to Sequence Run Number 14.

(3) A thermal conditioning system for the turbine was installed as shown in figure 2. This system was utilized to thermal-condition the turbine to a desired temperature prior to performing the ascent pressure history. The thermal conditioning system was installed prior to Sequence Run Number 52.

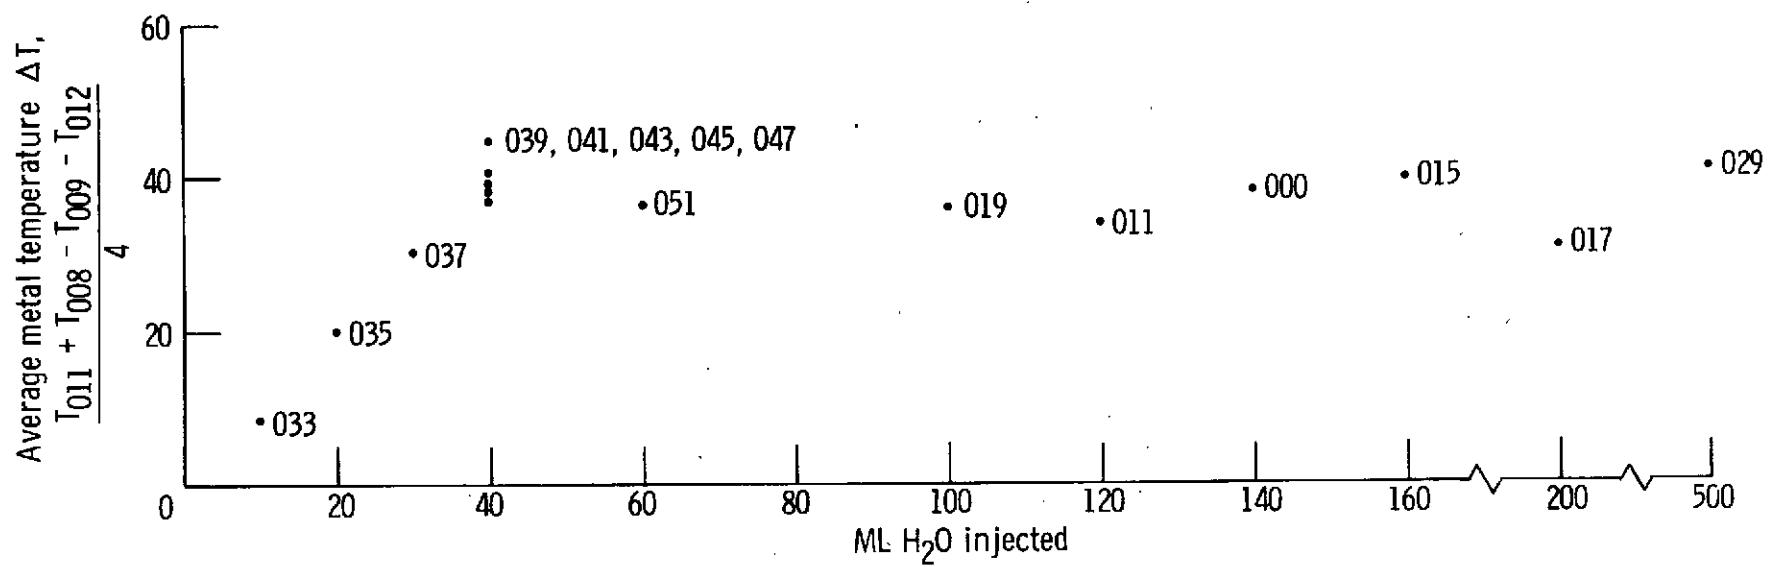
Figure 4. - Average metal temperature ΔT versus CC H_2O injected.

Figure 4 indicates the amount of turbine housing temperature drop which can be expected for various amounts of water injected. The graph indicates that amounts of water greater than 40 milliliters has little effect on the temperature drop. This is probably related to the amount of water which can be retained inside the turbine during the ascent curve. This was apparently substantiated by the occurrence during the run series conducted on July 20, 1974 when a total of 1900 milliliters of water was injected into the turbine over the course of 13 runs. Following the test, 1200 milliliters were found in the bottom of the tank. This indicates that the turbine retained an average of approximately 54 milliliters per run.

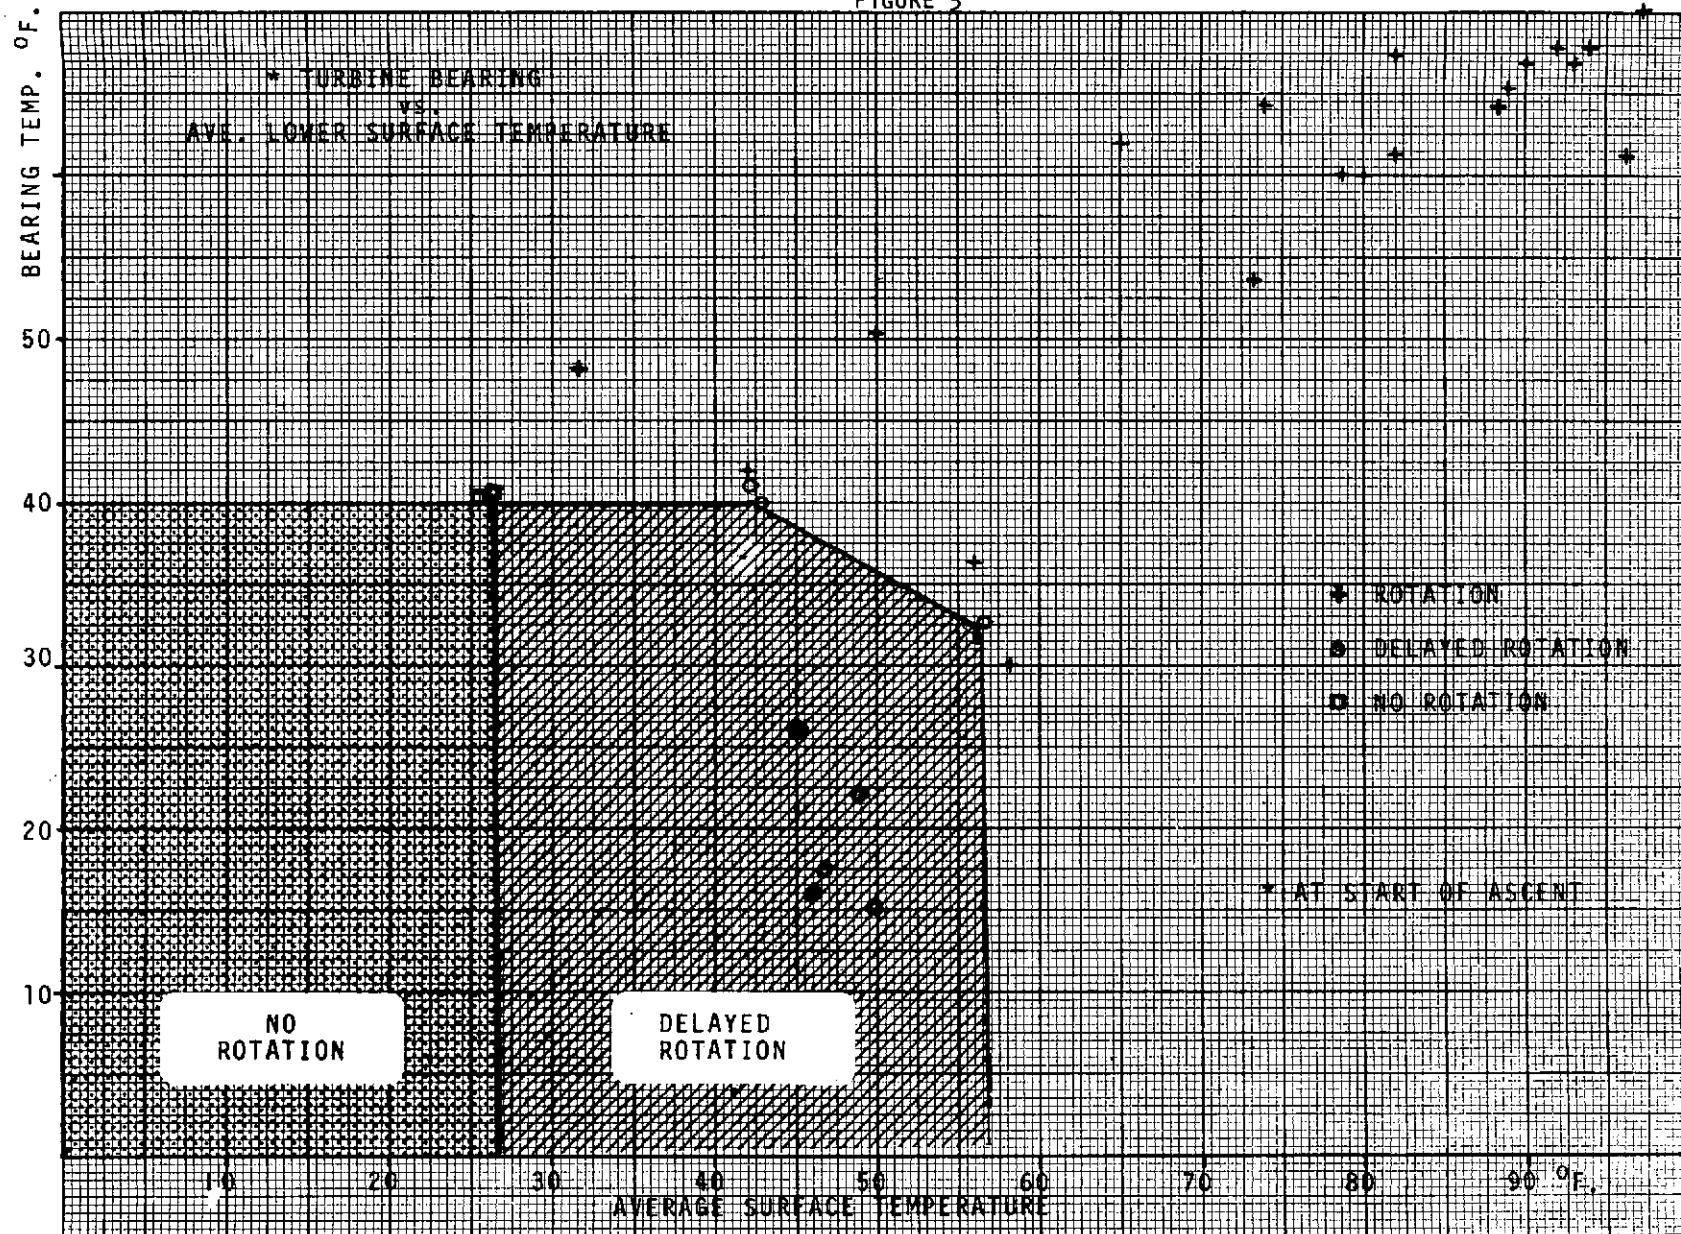
FIGURE 5

Figure 5 plots the bearing temperature against the average lower surface temperature at the start of ascent and indicates the type start obtained. The bearing temperature is indicative of the turbine upper surface temperature. The temperature conditions while delayed starts and complete freeze-up during the entire simulated flight sequence could be expected are indicated.

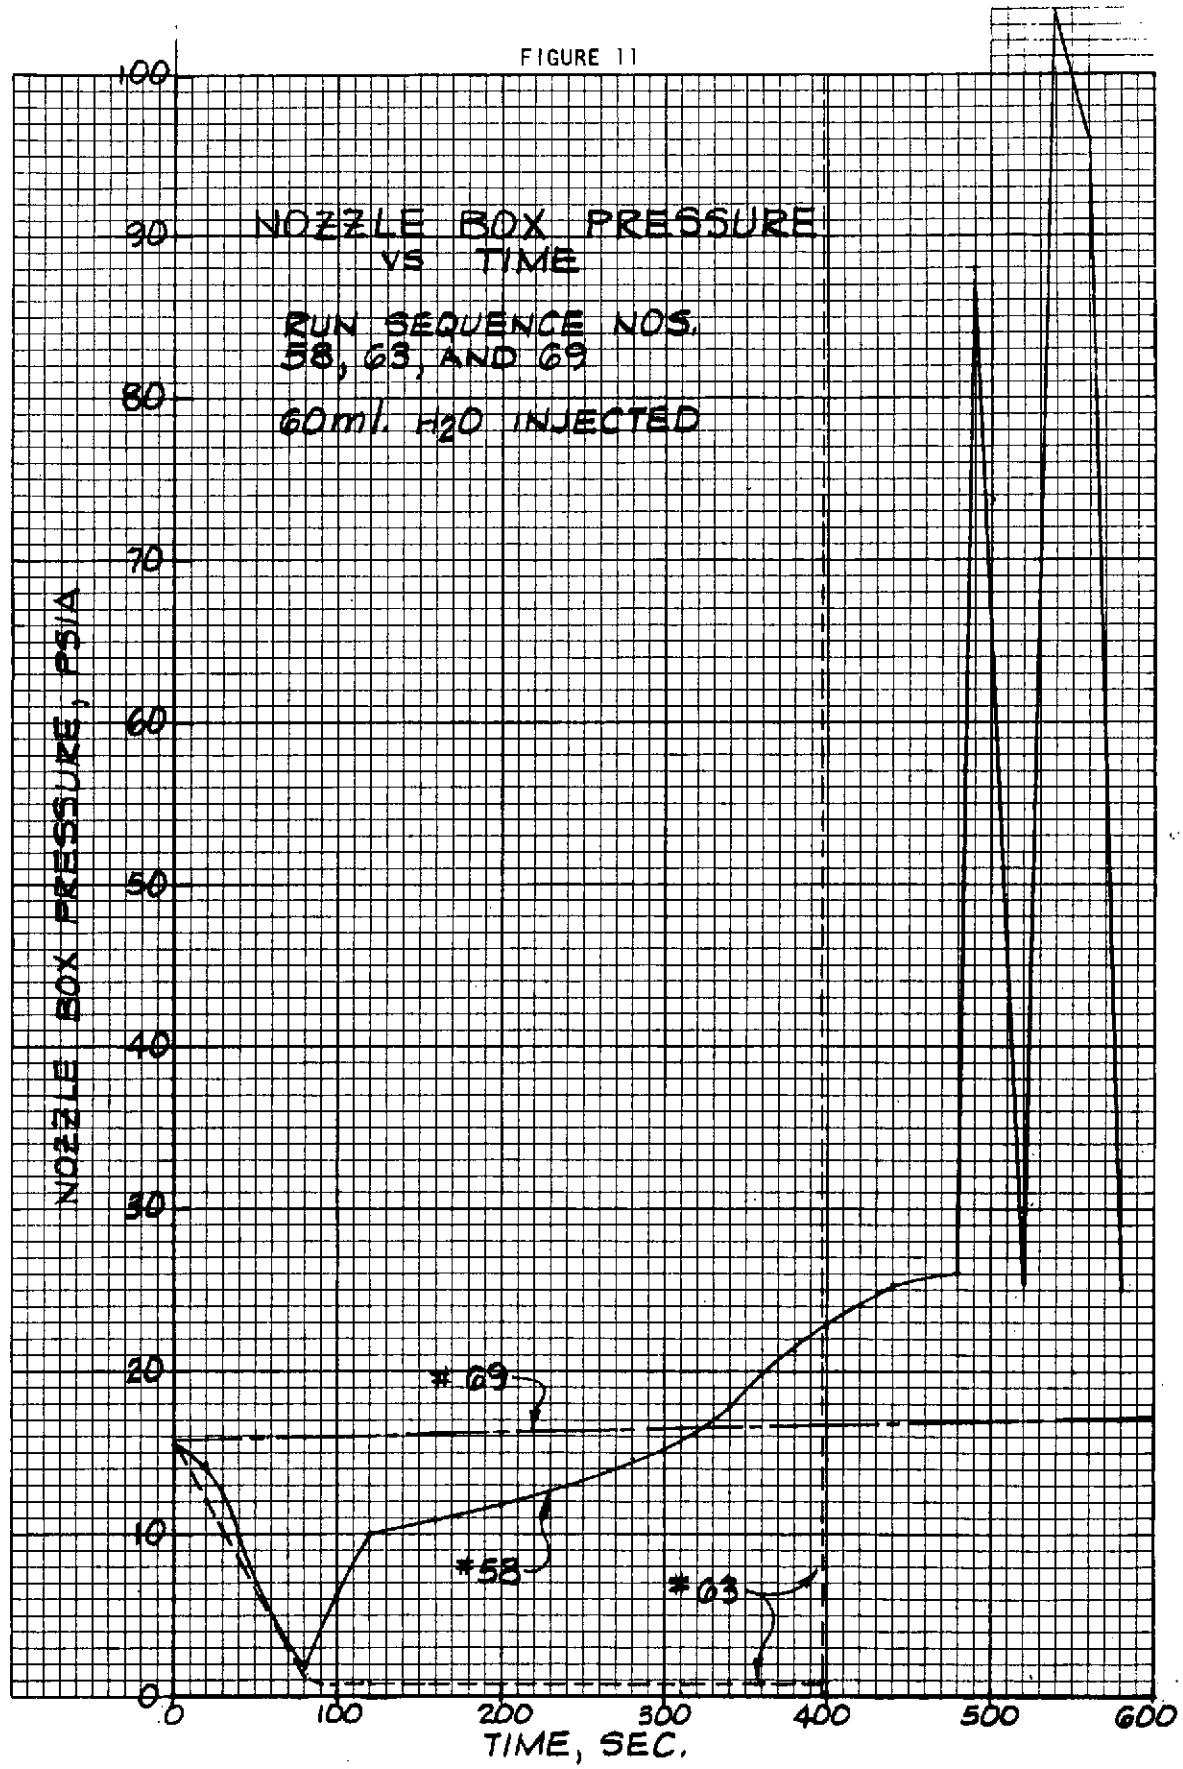
FIGURE 11

Figure 11 is a plot of turbine nozzle box gas space pressure against time for the same runs.

During test number 69, the turbine reactor surface temperature and turbine nozzle box gas space temperature (table II) indicate that the hydrogen peroxide did not react in the catalyst bed. These two parameters reached normal run temperature level during test number 58.

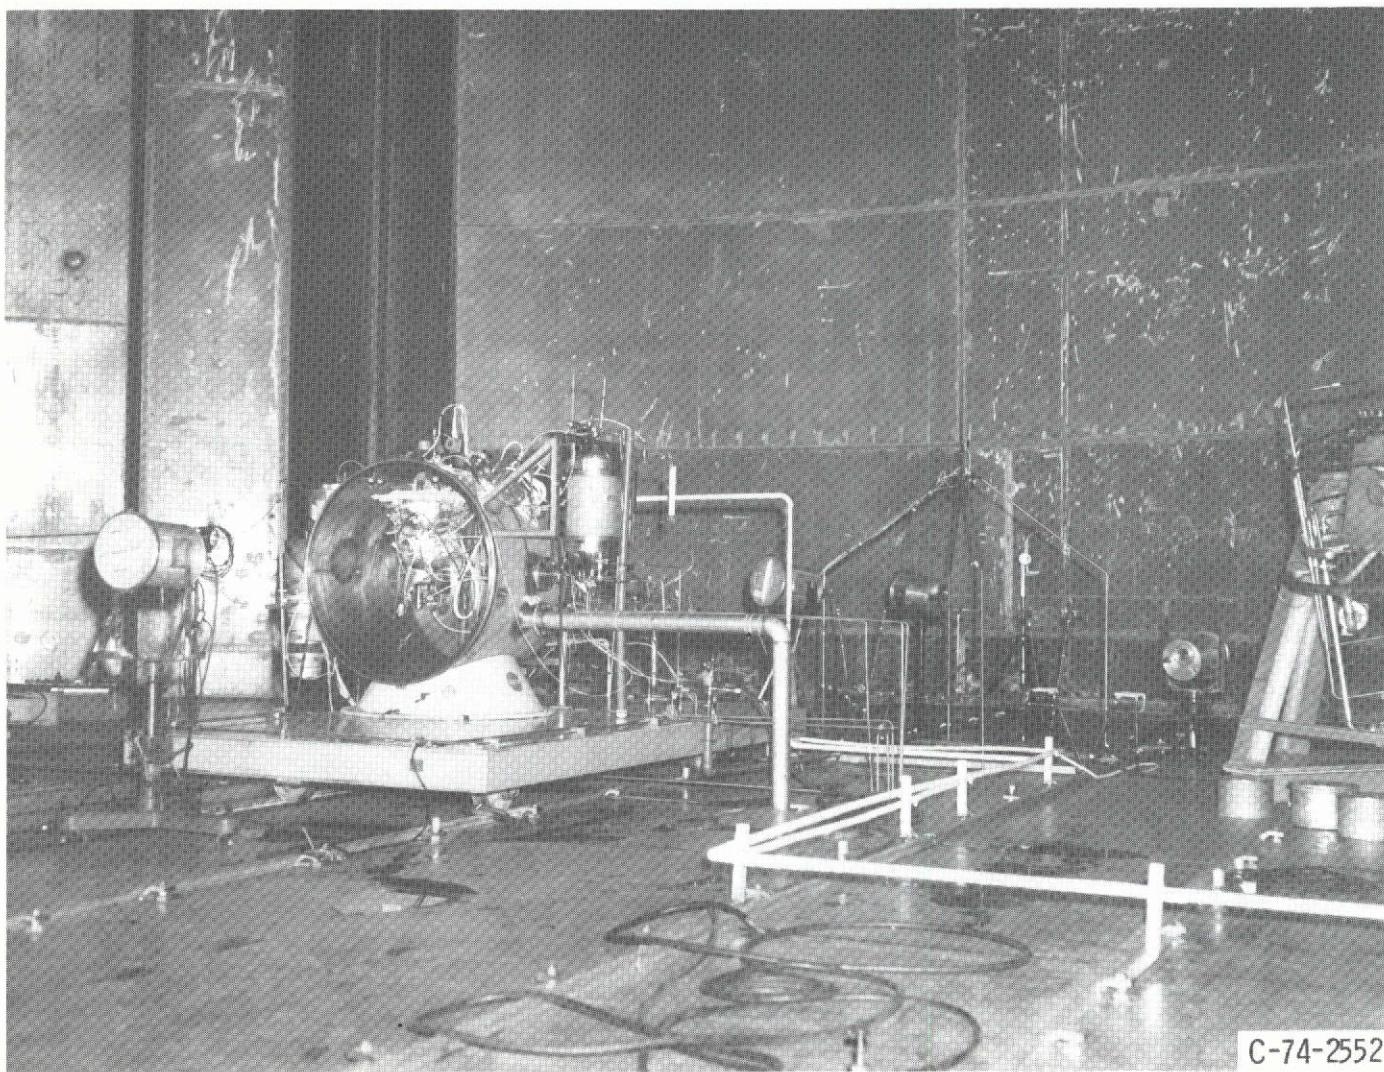
Figure 13.

(a) Figure 13, NASA photograph C-74-2552, is an overall view of the test equipment installed in the SPF vacuum chamber.

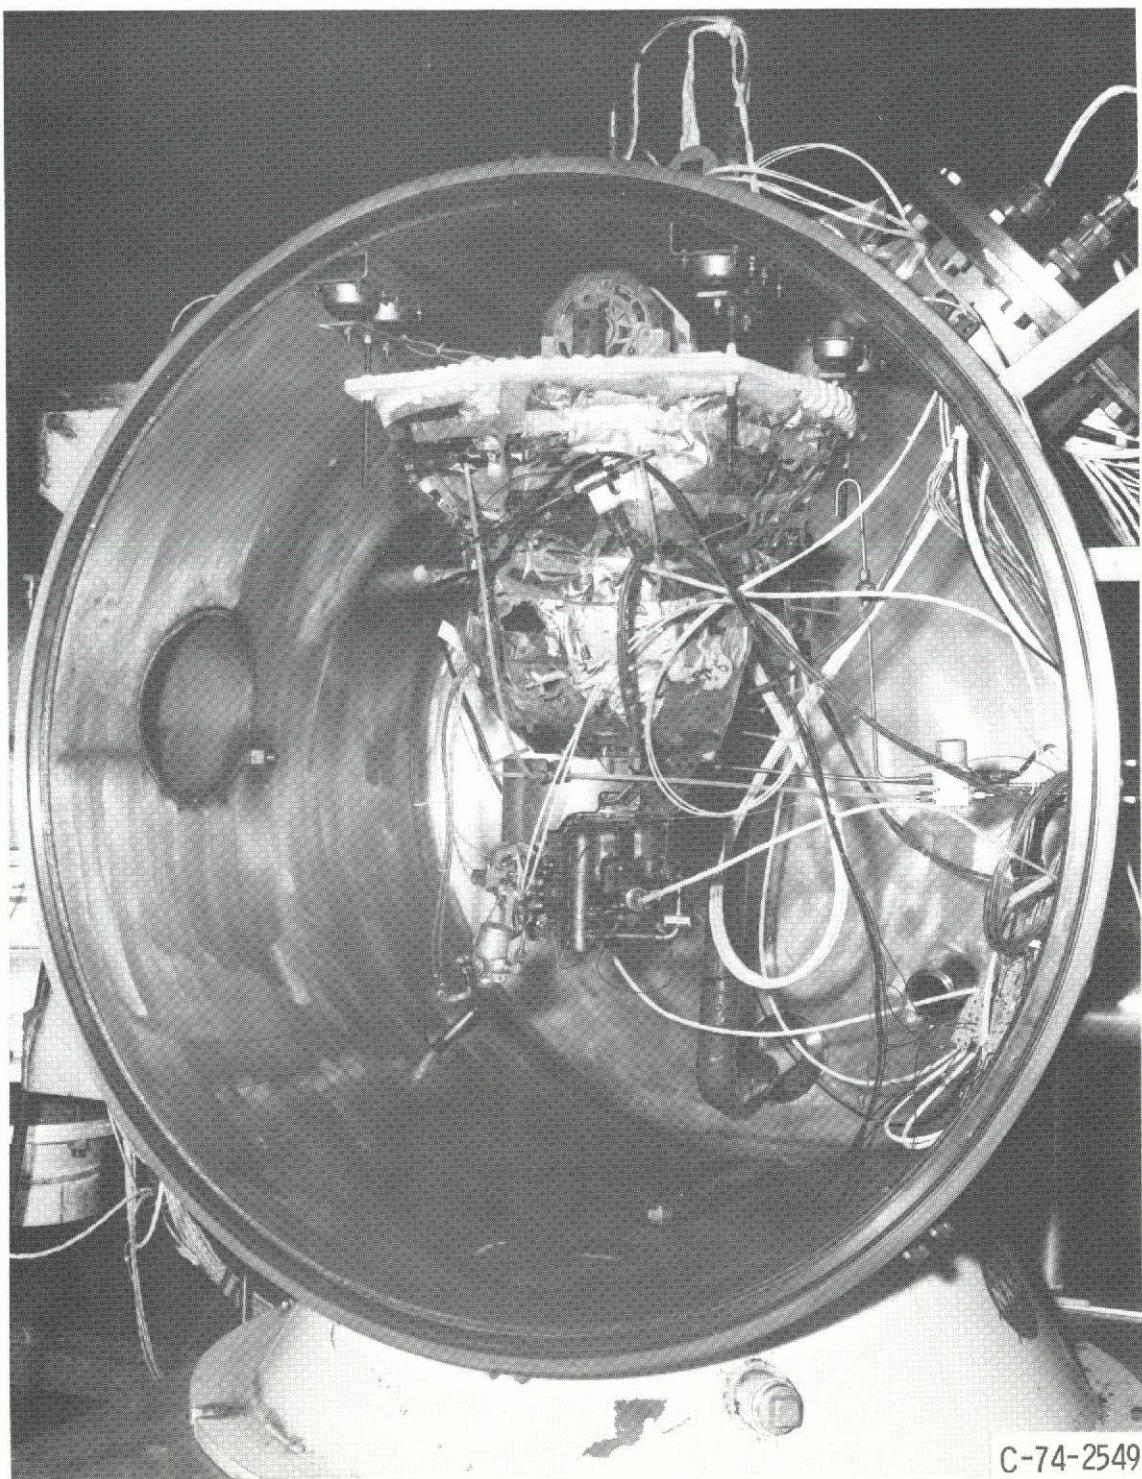
Figure 14.

(b) Figure 14, NASA photograph C-74-2549 shows the boost pump installed in the test tank.

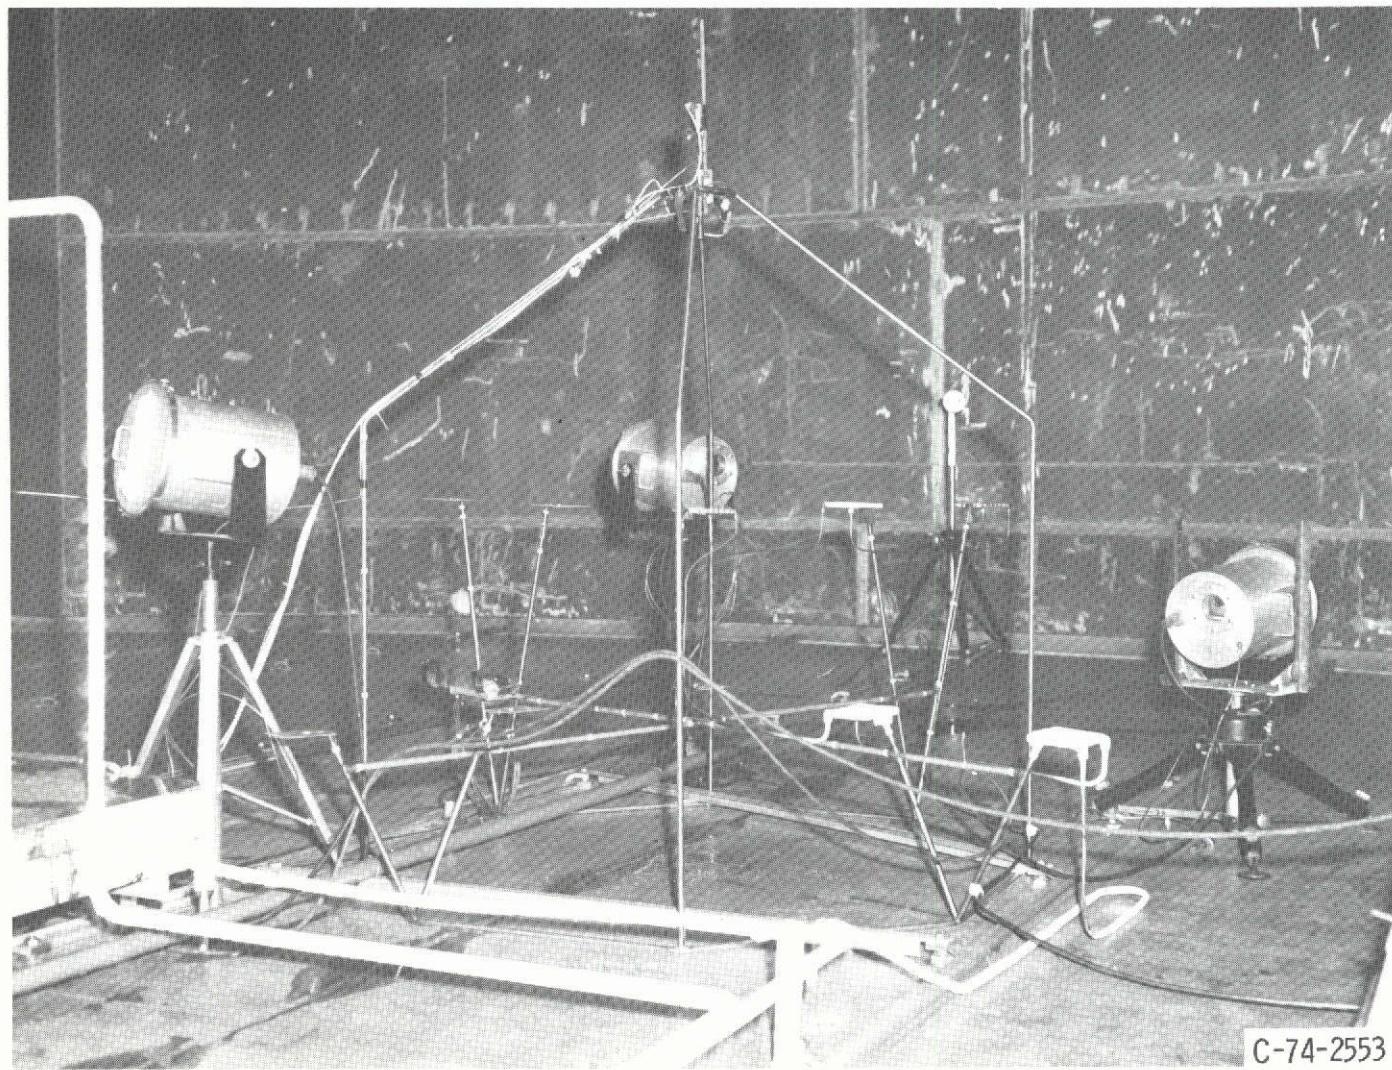
Figure 15.

(c) Figure 15, NASA photograph C-74-2553 shows the impingement test fixture.
